Dynamic Tests Of Short Sections Of Corrugated Metal Beam
Guardrail Series XIII

October 1968

State of California
Department of Public Works
Division of Highways
Materials and Research Department

October 1968
Interim Report
M & R No. 636392-4
D-4-37

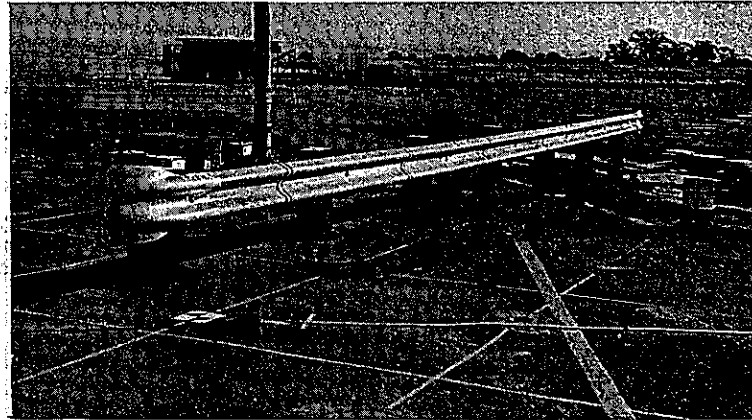
Figure 1

The installation for Test 131 consisted of a 37.5-ft free standing section of unanchored guardrail (Figure 1). This test installation was similar to many operational installations currently installed along California highways

except for the aforementioned machine bolts and round cut washers.

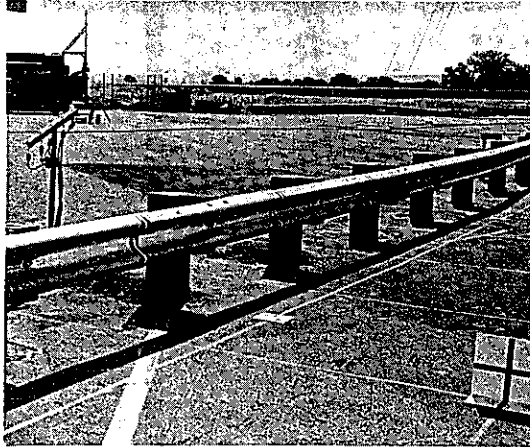
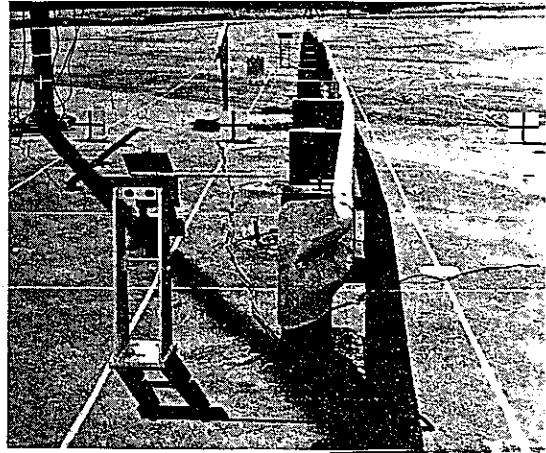
Because Test 131 clearly demonstrated that an unanchored 37.5-ft guardrail section was totally inadequate, the unanchored barrier length for Test 132 was increased to 62.5 ft. In an attempt to increase end rigidity, a slight flare was formed by modifying the block-out blocks at each end of the installation. The two end posts used no blocks and the second post from each end used 4-in. thick blocks (Figures 5a and 5b). At all four of these posts the bolt-round cut washer modification was installed. However, washers were not used under the heads of the remainder of the through bolts in order to obtain a comparison with

Test 131 where washers apparently prevented bolt "pull through" failures.

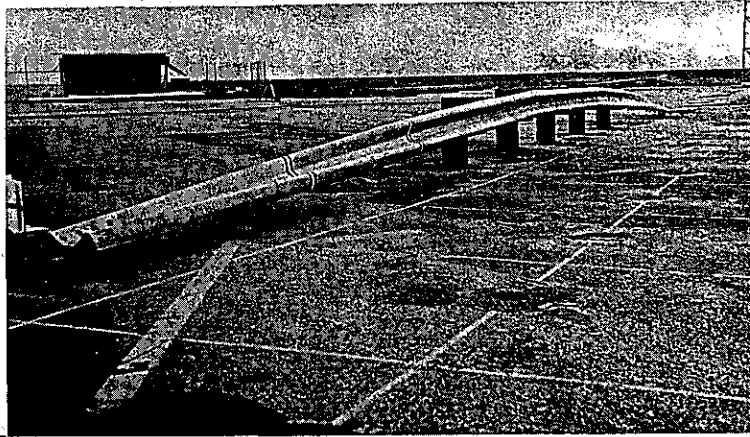
Figure 8

The first guardrail end anchorage design tested was developed by the Texas Highway Department and is referred to as the "Texas Twist". The test installation for Tests 133 and 134 consisted of a 62.5-ft section of guardrail with 18-ft 9-in. of the beam section at each end twisted 90 deg axially, bent down and bolted to fabricated steel posts cast in 18-in. diameter by 5-ft deep cylindrical concrete footings, Exhibit 3 (Appendix). There was no intermediate support in the sloping end sections between the concrete footing and the first post. The center 25-ft of the installation conformed to the California standard 27-in. high metal beam guardrail with round cut washers installed under the heads of all through bolts (Figure 8).

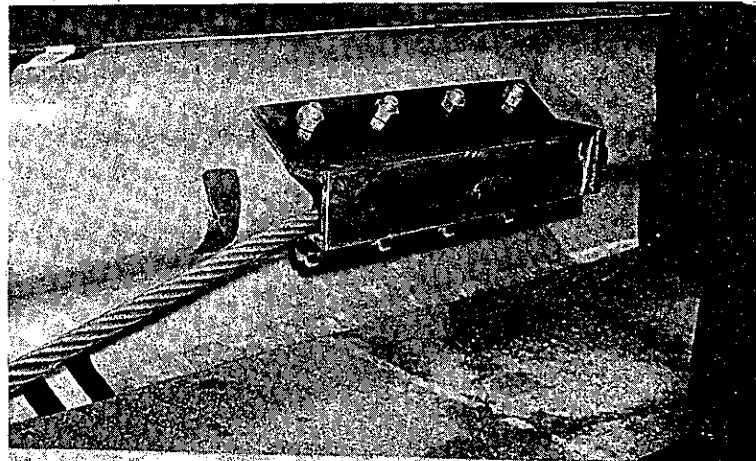
Figure 13

The test installation consisted of a 50-ft length of corrugated metal beam guardrail constructed on a parabolic flare. In order to reduce the lever arm effect of the axial force acting about the posts, block-out blocks were not installed on the end posts and 4-in. thick blocks were used on the posts next to the end. Round cut washers were used under all bolt heads. Each end section of the beam was secured with a 3/4-in. steel cable (breaking strength 21.4-tons) attached to the beam with a special fitting between the first and second posts (Figure 13).

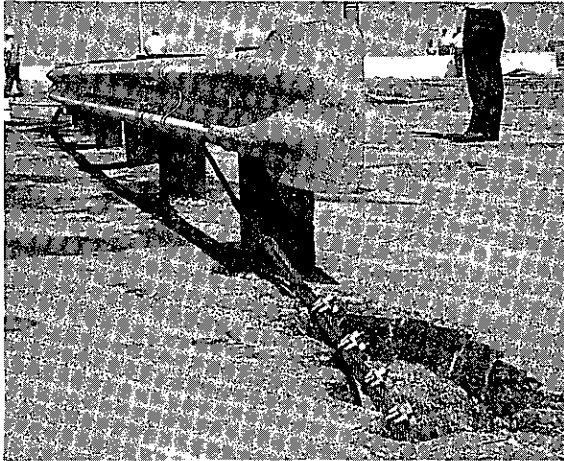
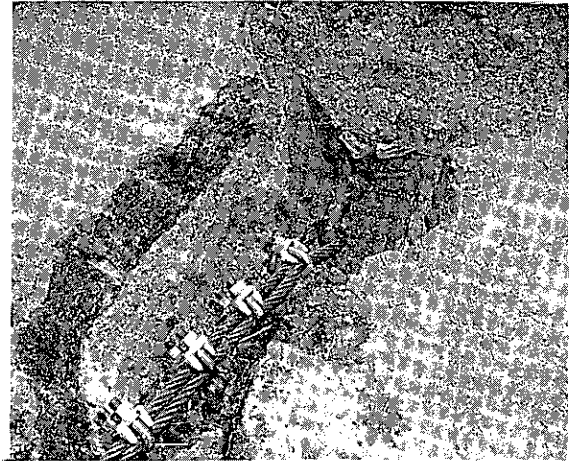
The other end of each cable was clamped to a 1 1/4-in. eye bolt attached to a steel 8 WF 17 section cast in an 18-in. dia by 5-ft deep cylindrical concrete footing (Figures 14 and 15).

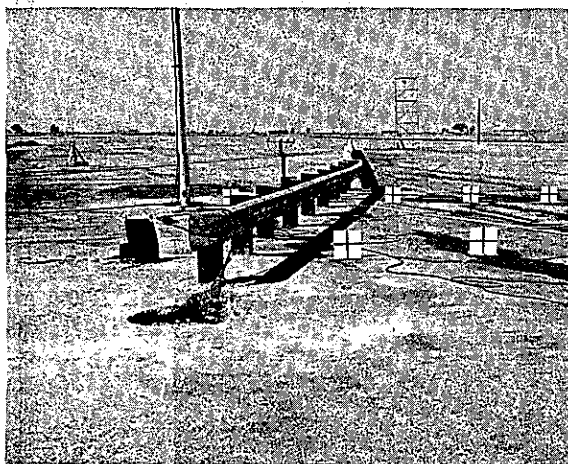
Figure 18

The success of the cable anchor in providing adequate beaming strength to a short section of guardrail prompted Test 136 where it was used to anchor the upstream end of a bridge guardrail approach flare. The test installation for Test 136 consisted of a 53-ft section of metal beam guardrail with the initial 12 ft at the downstream end constructed with enough curvature that the remaining 41 ft could be installed on a straight line thus forming a 4-ft offset from the face of a simulated bridge end post (Figure 18). The metal beam at the downstream end was secured to the nonreinforced concrete simulated bridge end post with two 1-in. dia high strength bolts. The bolts were inserted through 1-1/8 in. dia holes bored through the concrete. An 8- by 12- by 18-in. wood block-out block was placed between the guardrail beam and the concrete (Figure 19).

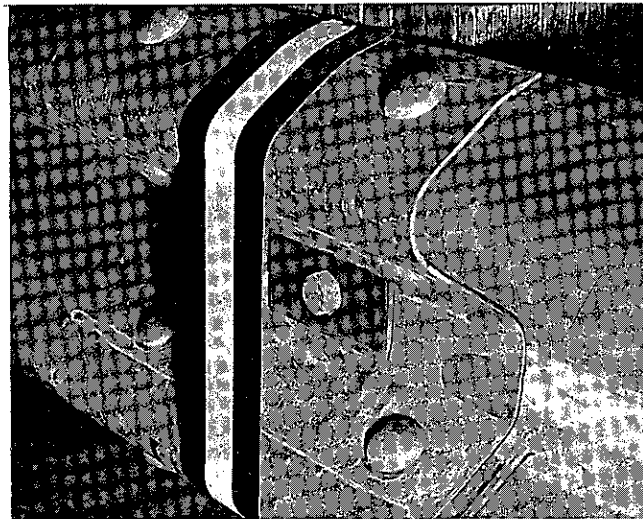
Figure 20

The upstream end of the metal beam guardrail was anchored with the cable anchor design tested in Test 135. Data from the preceding tests indicated that the use of round cut washers under the heads of the through bolts did assist in preventing bolt pull through failures. It was also evident that when the guardrail beam is adequately anchored, as in Test 135 the probability of bolt pull through failures or post splitting is minimized under those impact conditions. However, under a more severe impact it is conceivable that even with round cut washers, bolt pull through failures could occur. Consequently, it was decided that for Test 136 the round cut washers would be replaced with a 3- by 1-3/4- by 3/16-in. steel plate washers to provide additional bearing surface under the through bolt heads (Figure 20).

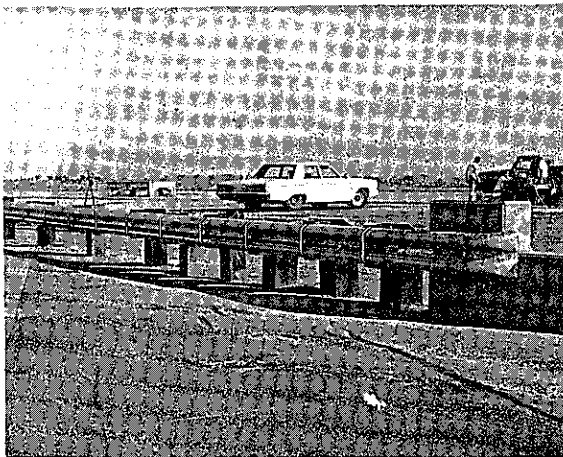
Figure 24

design details of the then current California Division of Highways Standard Plans, Exhibit 2 (Appendix). A 50-ft section of metal beam guardrail was constructed on a straight line with the upstream end offset 4 ft from the projected face of the bridge end post (Figure 24). The same cable anchorage installation used in Test 136 was employed to anchor the upstream end, Exhibit 1 (Appendix).

Finally, to minimize the pocketing noted in Test 136 and to provide improved transition from the semi-flexible metal beam guardrail to the rigid concrete bridge rail, the guardrail post spacing near the concrete bridge end post was decreased to 3-ft 1-1/2-in. Also the three timber guardrail posts nearest to the bridge rail end were 10- by 10-in. rather than the standard 8- by 8-in. posts. Steel plate washers were used on all through bolts as in the preceding Test 136.

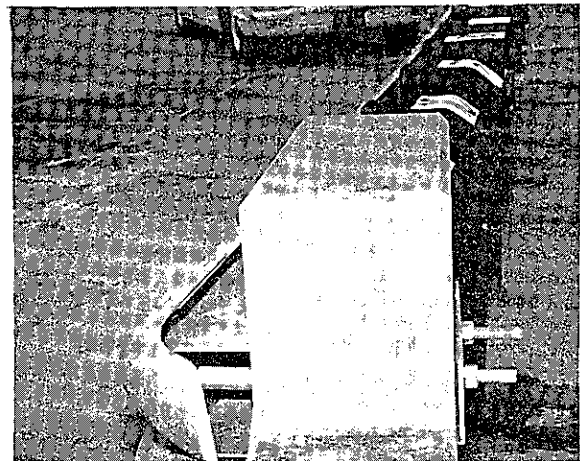
Figure 25

The block-out block between the guardrail beam and the concrete was fabricated of 1/4-in. steel plate rather than the wood block used in the preceding test (Figure 25). This was done to add rigidity to the system and prevent the crushing of the block.

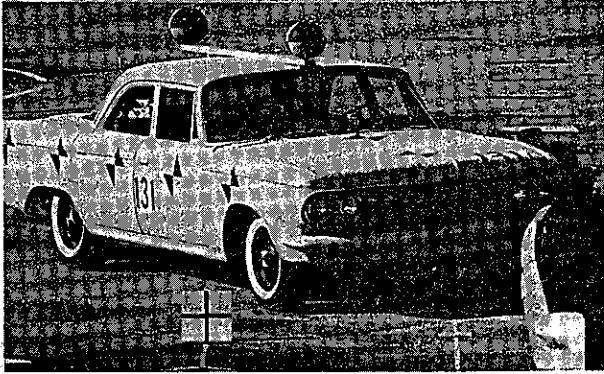
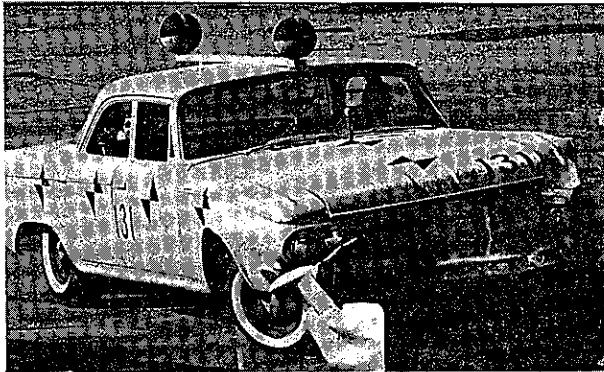
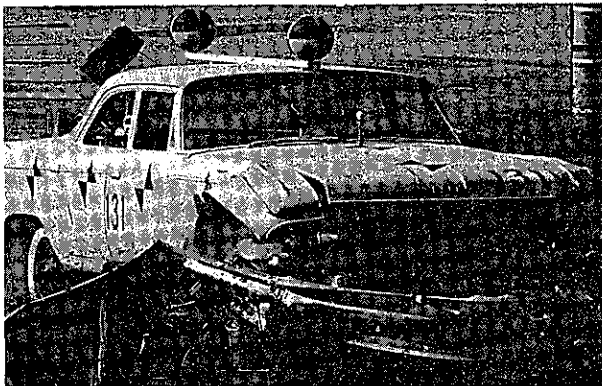
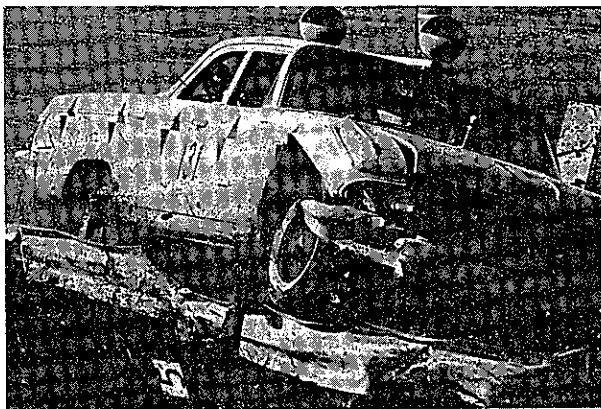
TEST 131 PLATE A

The test vehicle in Test 131 impacted the barrier near the center post at 63 mph/25 deg. The beam pocketed almost immediately upon impact (Figure 2), was pulled free of all but one of the posts, and was dragged, intact, by the vehicle as it penetrated through the installation with only a 3-deg change in direction, Plate A (Appendix).

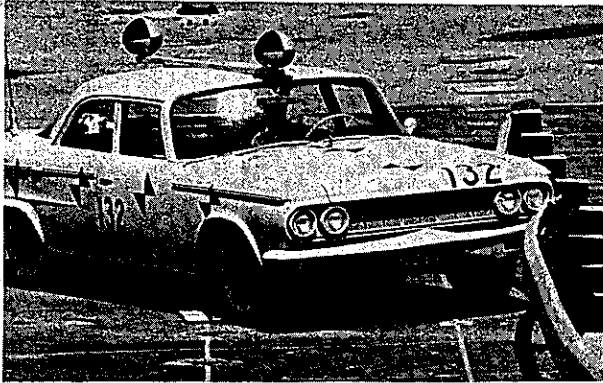
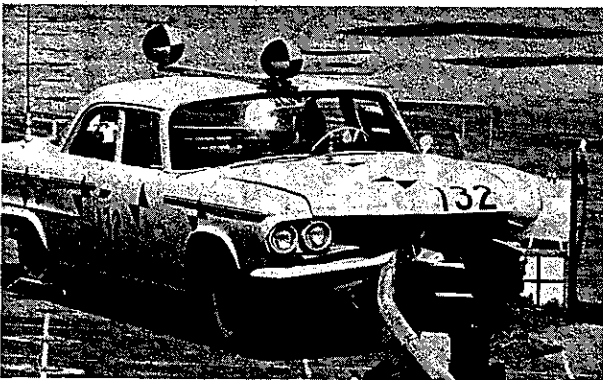
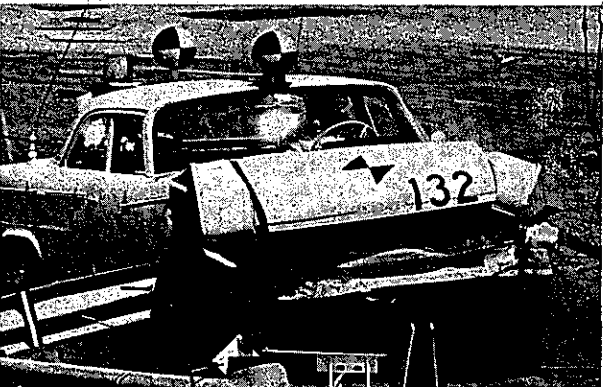
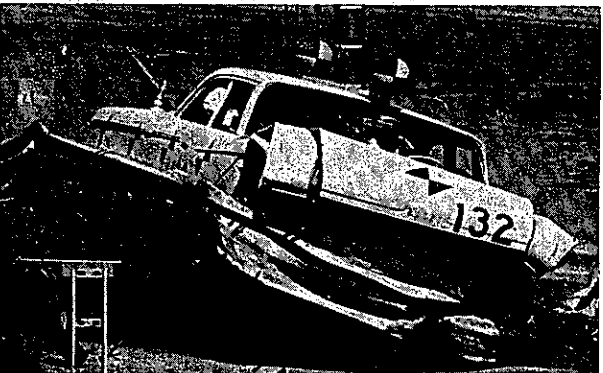
TEST 132 PLATE B

The test vehicle in Test 132 impacted the barrier 2-ft downstream of post 4 at 61 mph/25 deg. As in Test 131, the beam was pulled free from the posts and dragged, intact, by the vehicle as it penetrated through the barrier with a 6-deg redirection angle, Plate B (Appendix). The additional barrier length was still not sufficient to prevent a repeat of the failure experienced in Test 131. The number of posts in a 62.5-ft section of guardrail was insufficient to develop the combined beam-to-post strength required to resist the axial load imposed by a severe impact.

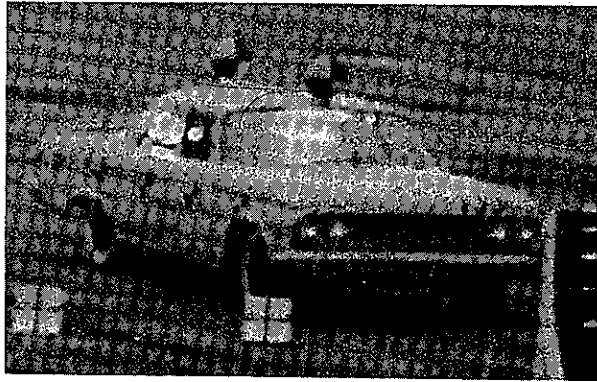
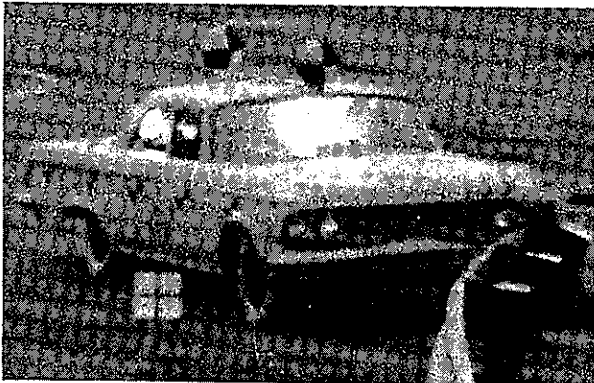
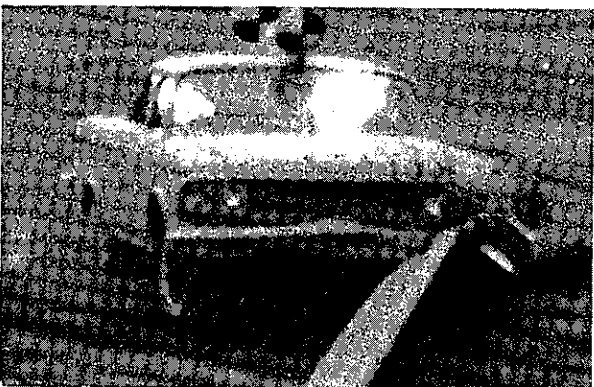
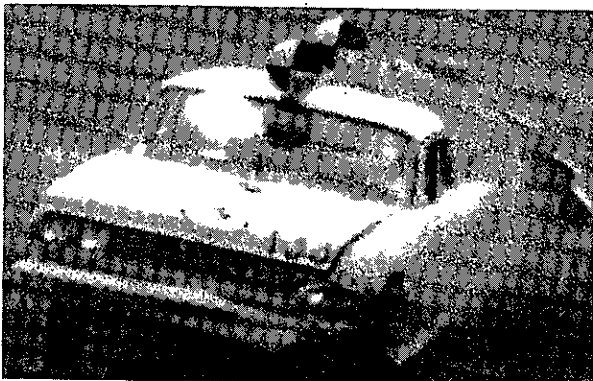
TEST 133 PLATE C

The vehicle in Test 133 impacted the barrier approximately 2-ft downstream of post 2 at 56 mph/30 deg and remained in contact for the remaining 35-ft of barrier before being effectively redirected at an exit angle of 7 deg, Plate C (Appendix). There was only a moderate

amount of vehicle roll even though the barrier posts all rotated back through a considerable angle (maximum permanent rotation 43 deg, maximum dynamic rotation 46 deg) illustrating the effectiveness of the blocked-out beam principle. There were permanent beam deflections of 2.8 ft horizontal (back) and 6 in. vertical (up).

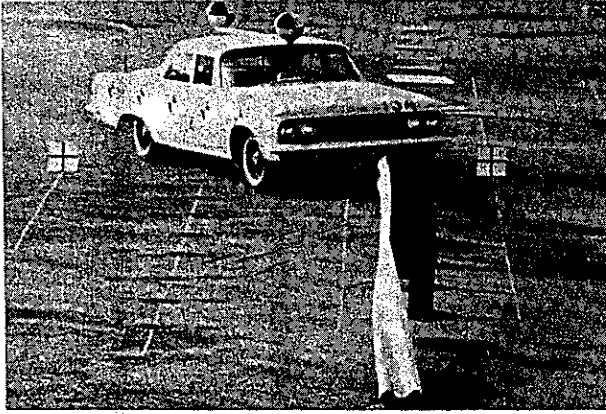
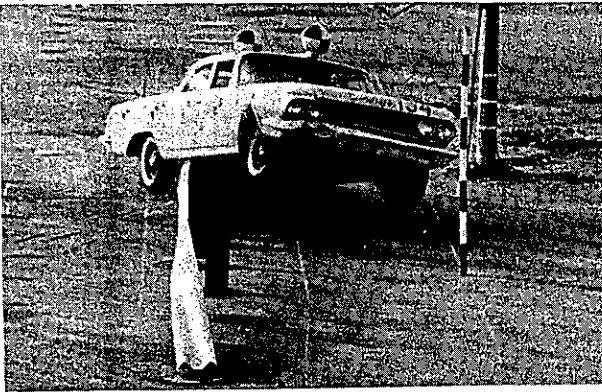
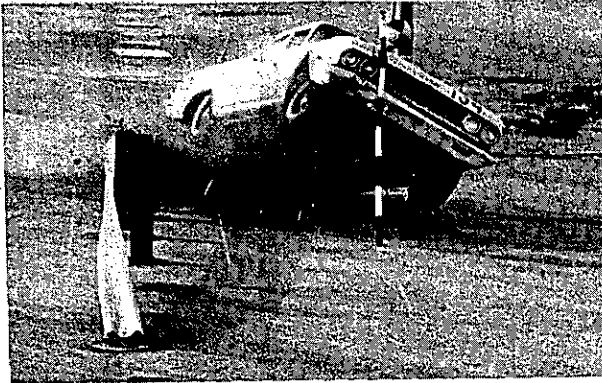
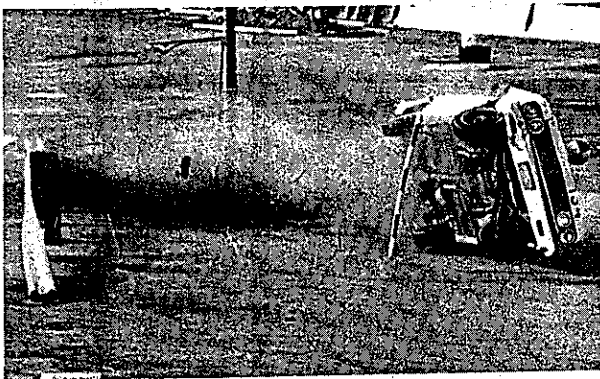
TEST 134 PLATE D

2. Although Test 133 demonstrated the structural adequacy of the "Texas Twist" design in providing effective anchorage for short sections of guardrail, Test 134 showed that a hazardous condition exists when vehicle impact occurs at the upstream sloping end anchorage.

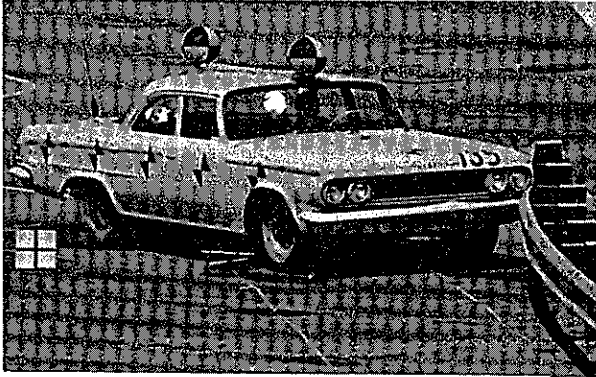
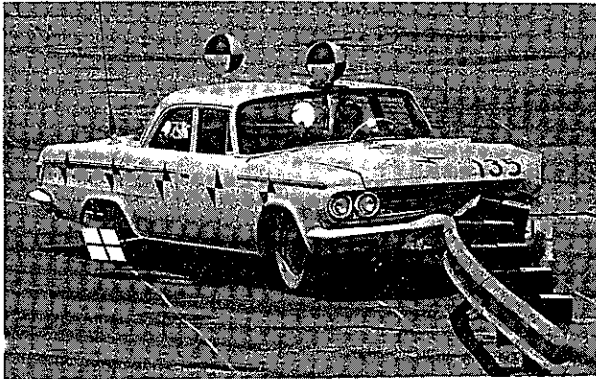
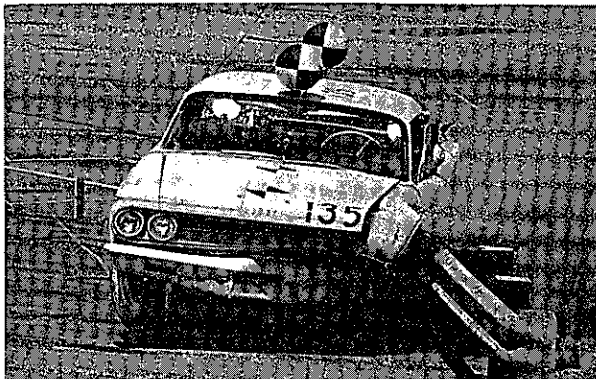
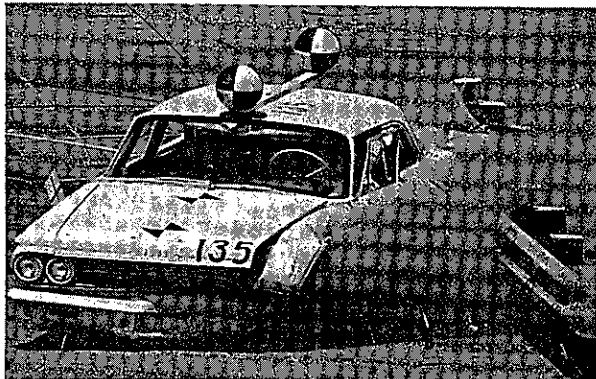
TEST 135 PLATE E

The test vehicle in Test 135 impacted the barrier between posts 2 and 3 at 59 mph/28 deg and remained in contact

with the barrier for approximately 22 ft before being effectively redirected at an exit angle of 24 deg, Plate E (Appendix).

Although vehicle dynamics and barrier reaction were considered satisfactory through impact, deceleration forces were fairly severe as there was a tendency for the vehicle to pocket the beam. Analysis of high speed data film revealed that this pocketing was due, at least partially, to the parabolic configuration of the barrier, since the curved beam had to deform through a straight line before the restraining force of the anchors was effectively developed. As a result, it is recommended that flares be placed on a straight line between anchor points, particularly on short sections, even though there is a possibility of increasing the collision impact angle by doing so.

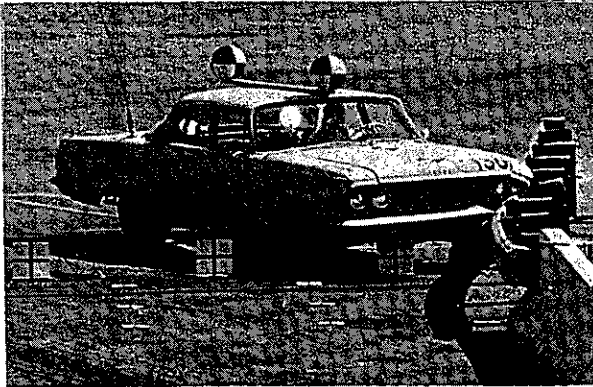
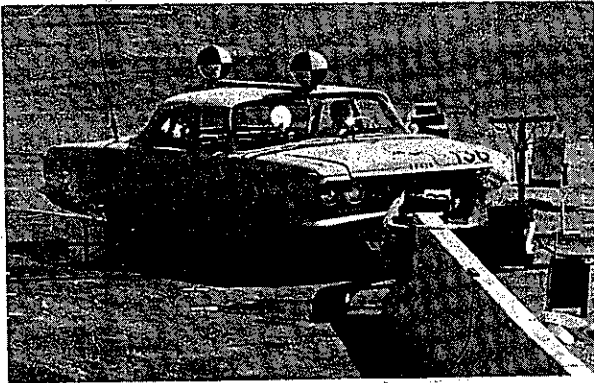
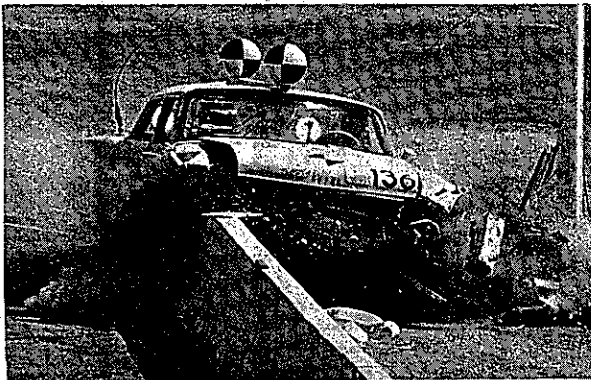
TEST 136 PLATE F

As the vehicle was being redirected (approximately 12 deg) the concrete end post failed through the connecting holes, allowing the guardrail beam to pull free, thus permitting the vehicle to penetrate the barrier. As the vehicle progressed through impact, the right front wheel struck the end of the concrete end post throwing the vehicle into a violent counter clockwise roll-over. The vehicle came to rest 45 ft beyond impact in a regained upright position (Figure 22), Plate F (Appendix).

Analysis of the data film indicates that even if the concrete end post had not failed, beam deflection and pocketing were already occurring to such an extent that the vehicle would not have been redirected sufficiently to avoid an end-on collision into the concrete bridge end post.
